# Manhole Inspection Summary

Manhole # S55K\_\_048MH

Insp Date: **6/2/08 2:30 PM**

**Location** Address: **800 s conkling ave**

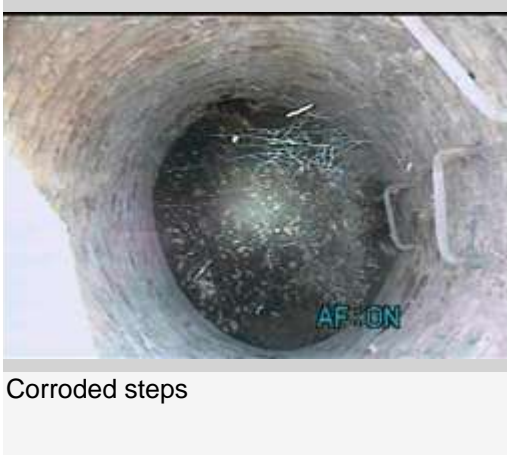
Defect 1

Count: **4** Missing: **1** ☒ **Corroded**

Corroded steps

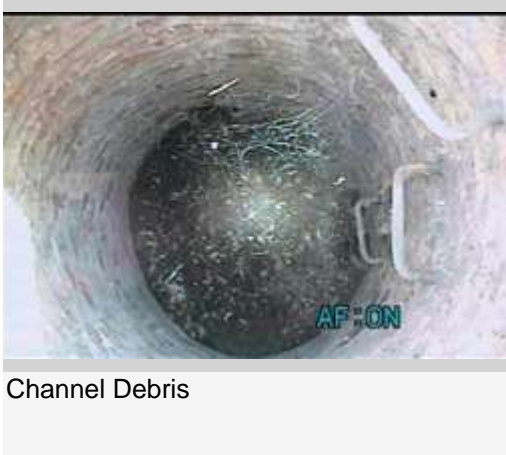
Defect 2

Condition: ☐ Sound ☐ Cracked ☐ Root Intrusion ☐ Deteriorated ☐ Leaks ☒ **Debris**

Channel Debris

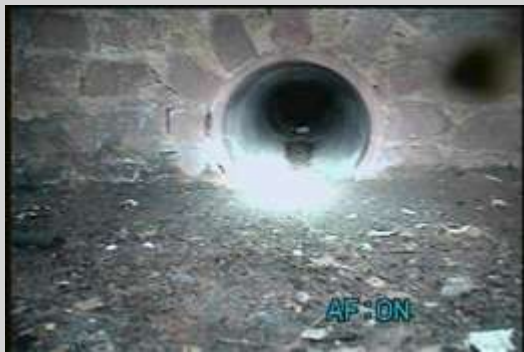
12 O'Clock Outflow

8 in. Circular Gravity Sewer  
Pipe Out @ 12 O'Clock
